THE FRENCH QUARTER'S MOST SPANISH STREET

BY Richard Campanella

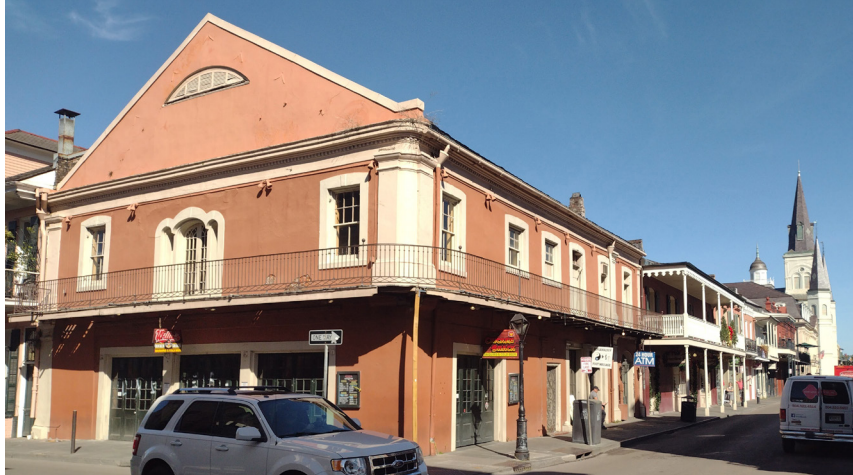
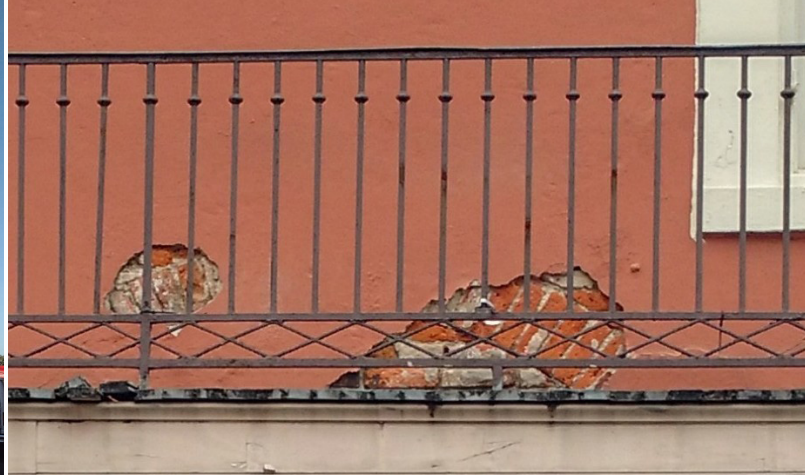
LEFT: Spanish-style brick arch revealed behind stucco of 601 Chartres St. RIGHT: Exposed brick under stucco at 601 Chartres St. *Photos by Richard Campanella.*

Let's go down the 600 block of Chartres door by door. At the corner of Toulouse and Chartres (601-607 Chartres) is the circa-1795 Reynes House, originally a townhouse evocative of Spanish architecture in the Caribbean and Latin America. It was converted to a storehouse in the 1830s; used as Victor's Grocery from 1896 to 1962; later a bar and restaurant and now a chicken joint. What you can see of its Spanish Colonial traits are its stucco, pilasters and balcony with austere cast-iron railings; what you cannot see are its high arched openings, which were later remodeled but recently visible thanks to some crumbled stucco.
